Manhole Inspection Summary

Manhole # S21CC_026MH

Insp Date: **10/24/07 10:01 AM**

Location Address: **1822 WINCHESTER-RIGGS**

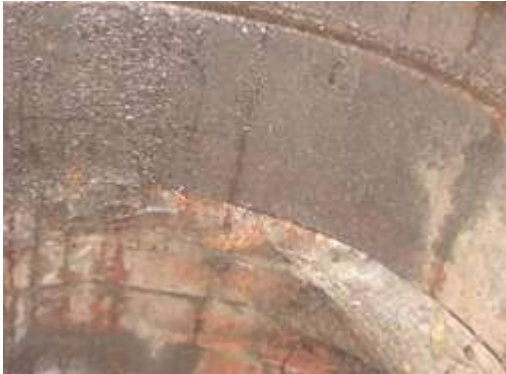
Defect 4

Condition: ☐ Sound ☒ **Cracked** ☐ Root Intrusion ☐ Loose Brick ☒ **Deteriorated**

DETERIORATED AND CRACKED
CHIMNEY

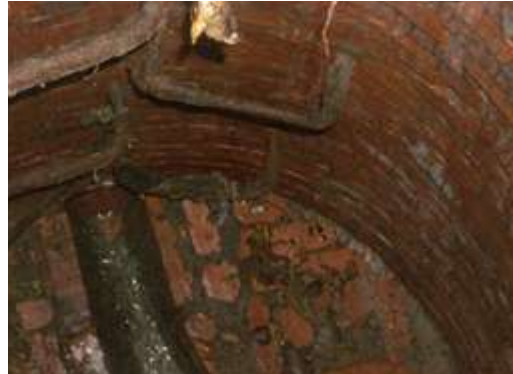
Defect 3

☒ **Evidence Of Surcharge** Depth: **2** (ft.) ☐ Active Surcharge Present

SURCHARGE EVIDENCE ON STEPS

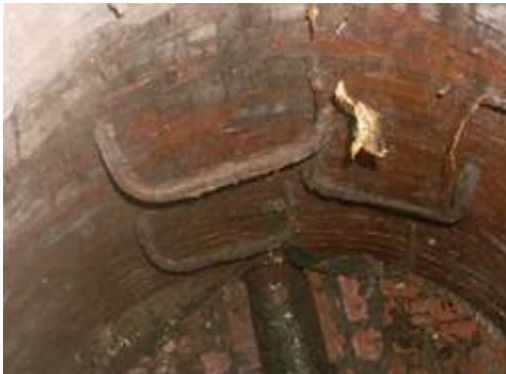
Defect 2

Count: **4** Missing: **1** ☒ **Corroded**

CORRODED STEPS

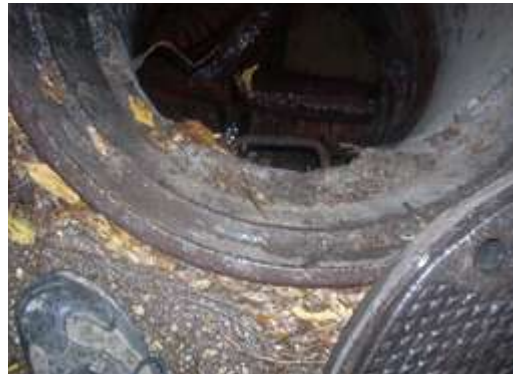
Defect 1

Offset: **1** (in.)

FRAME OFFSET
